# **INDOOR AIR QUALITY ASSESSMENT**

**Greenfield Public Library  
402 Main Street  
Greenfield, Massachusetts**

Prepared by:  
Massachusetts Department of Public Health  
Bureau of Environmental Health  
Indoor Air Quality Program  
November 2019

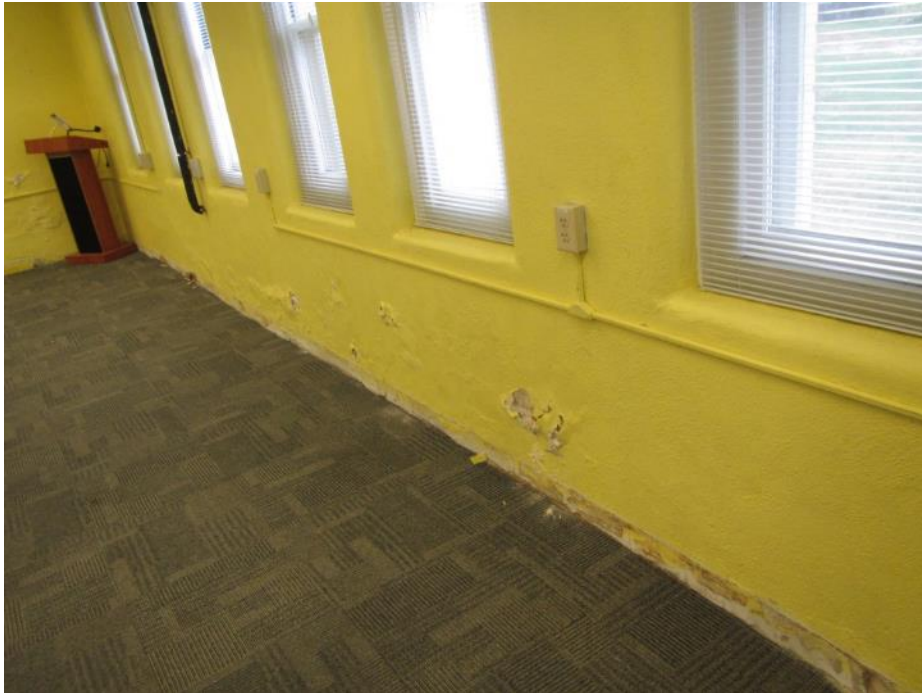
**Picture 1**

Room B101 had extensive water damage along its western wall (Picture 1). It also appears that repairs were attempted in the past in the form of gypsum wallboard (GW) patches used to fill holes in the base of the plaster wall (Picture 2), as indicated by the presence of paper inside the wall. The use of GW as a patch is inappropriate since the paper backing can become mold-colonized if chronically wet. The likely source of moisture causing this damage is pooling water against the foundation. Cement slabs were placed against the foundation to form a walkway and provide some amount of water drainage from the building. Chronic exposure to

**Room B101 had extensive water damage along its western wall**

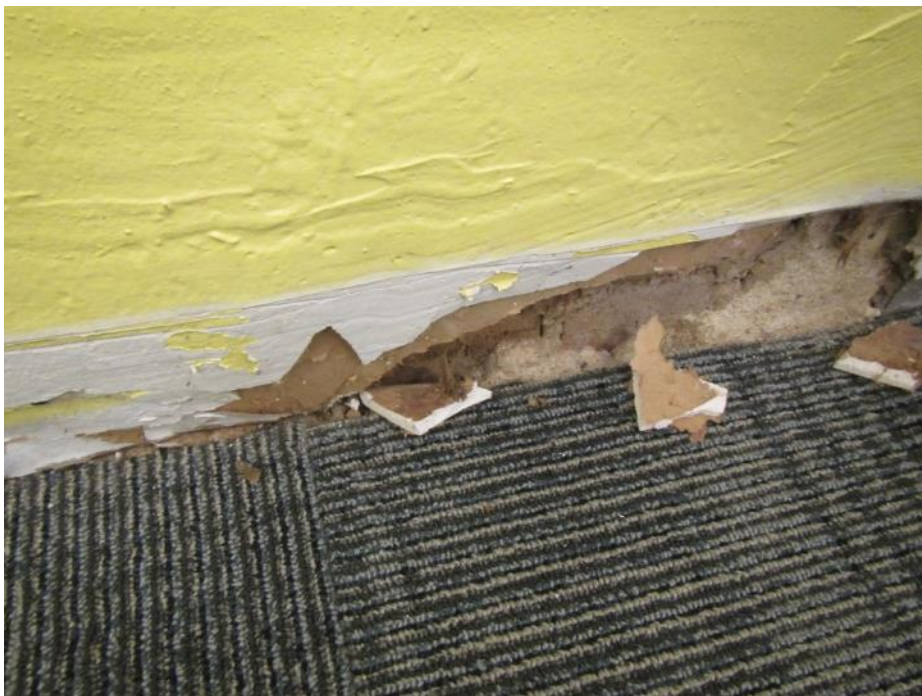
**Picture 2**

**GW inside plaster wall**

1. Consider implementing recommendations in the 2002 report that have not already implemented. A copy of the 2002 report is attached as Appendix A.
2. Remove GW used to repair the basement wall in B103. Repair with an appropriate material (e.g., cement board) that is not susceptible to mold growth.
3. To prevent future water damage from rain/groundwater in basement rooms a number of options to improve drainage from the west-facing wall of the 1907 building can be considered:
  - Install a French drain at the base of the wall;

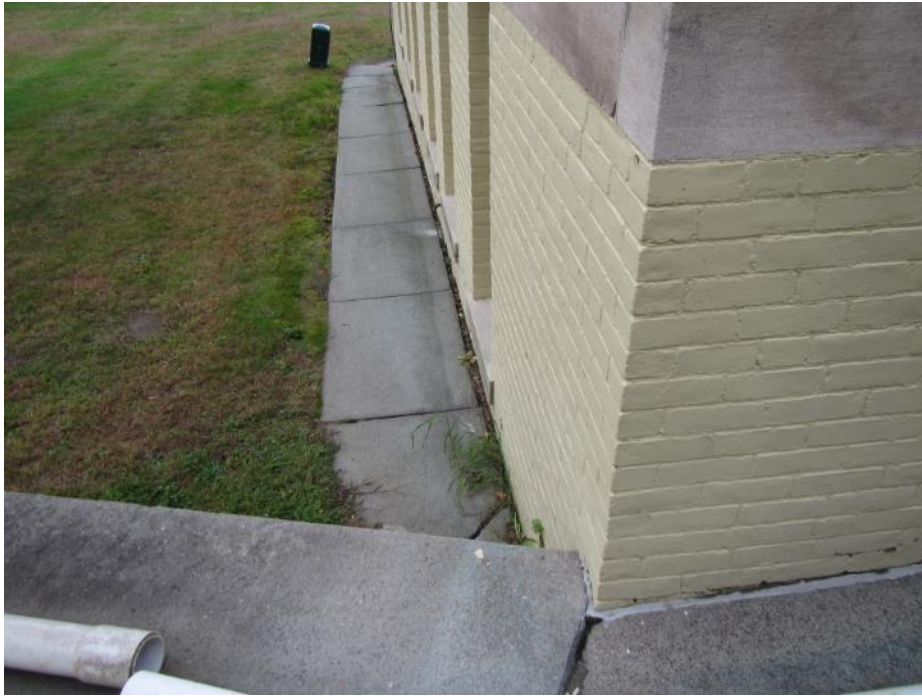
**Picture 3**

rainwater has resulted in the cement slabs subsiding and losing sealant. In addition, the subsidence has created a trench next to the building which will further prevent drainage (Picture 3). Water likely accumulates in the trench, which then penetrates through the exterior wall to damage interior wall plaster and serve as a moisture source for water vapor to accumulate beneath carpet tiles.

**Subsiding and ajar cement slabs at base of west wall  
(Note missing sealant in slab/wall junction)**

- Install a water-impermeable apron that resists settling to drain water away from the wall like the tarmac apron installed on the westernmost wall of the building (Picture 7);

- Install a gutter/downspout system to reduce rainwater impact on the cement slabs.

Once installed, reset the cement slabs in a manner to prevent settling.

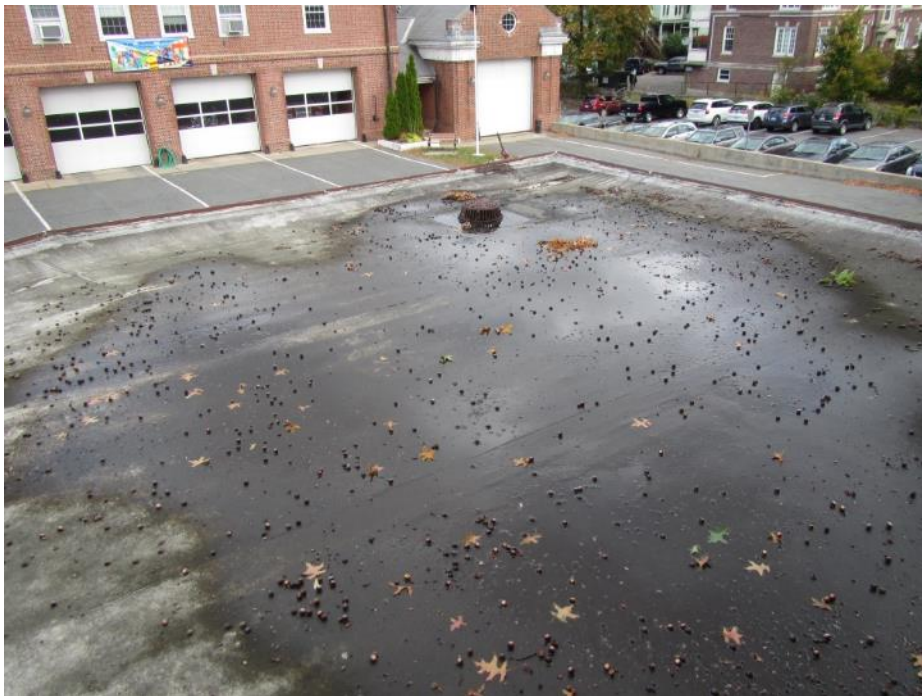
**Picture 4**

Water-damaged ceiling tiles were observed in a number of areas. Some of the observed stained tiles were from roof leaks that have reportedly been repaired. The roof of the building was also examined. The roof membrane had become loose, resulting in pooling water (Picture 4). Debris is also present from tree branches that overhang the roof. Debris holds moisture on the roof, which can damage the membrane and can be attractive to pests.

**Pooling water on roof**

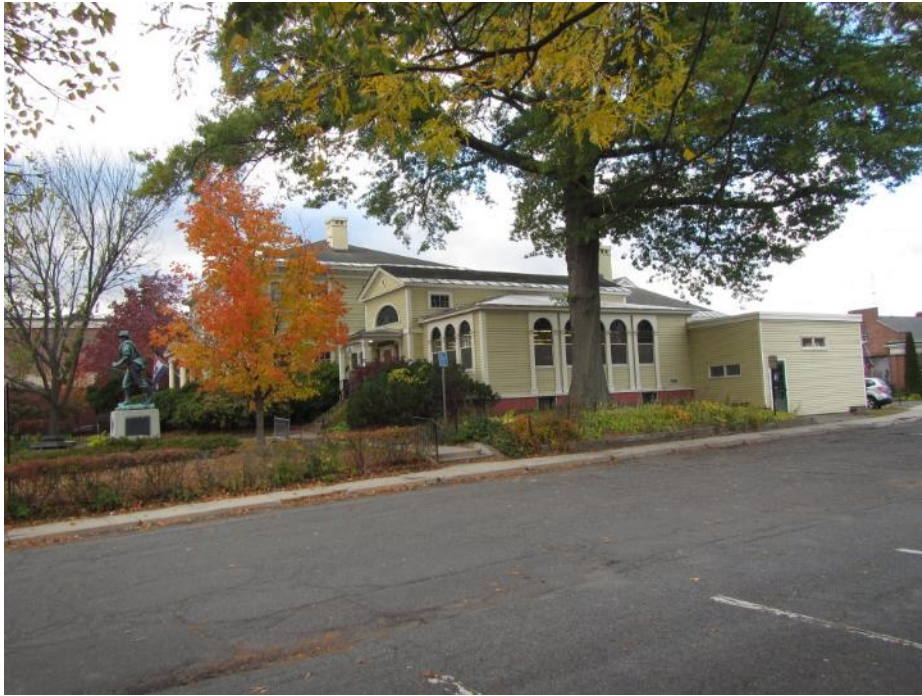
**Picture 5**

An oak tree exists near the southeast corner of the GPL property, which overhangs the roof (Picture 5). This tree poses a number of hazards to the GPL as well as a possible danger to free egress for the Greenfield Fire Department (GFD) from its firehouse driveway:

- As reported by Greenfield public officials, the roots of the oak tree are entering sewer pipes for the GPL, resulting in blockage.
- Leaves and acorns accumulate around the flat roof drain, which creates a dam that inhibits rainwater drainage from the roof. This condition can also lead to ice accumulation blocking this drain, which can lead to water running off the roof to moisten exterior walls.

- The oak tree prevents sunlight from drying the eastern wall of the GPL.
- The oak tree is a possible danger to the GPL due to its distance from its exterior walls. The recommended safe distance from which an oak tree should be planted is recommended to be approximately 98 feet (33 yards) from the exterior of a building (BI, 2015). Soil subsidence may also be caused by oak tree roots, which can undermine the structure of a building to cause wall and floor cracking as well as other related damage. To prevent subsidence, a 98 feet distance is recommended (Williams, A. 2006). Within this distance, severe weather may

result in the tree falling onto the GPL or having the tree roots damage the sewer service. The oak tree is well within 98 feet from the building.

**Oak tree overhanging building**

The Federal Emergency Management Agency (FEMA) provides a number of recommendations in order to prepare for severe thunderstorms. Of note FEMA recommends “Cut down or trim trees that may be in danger of falling on your [building]” (FEMA, 2018). Given the proximity to the GPL, the damage done to sewer lines and its location near the GFD driveway, removal of the oak tree should be strongly considered.

4. It is highly recommended to remove the oak tree from the southwest corner of the building to improve roof drainage and prevent potentially catastrophic damage in severe wind conditions/heavy rain.

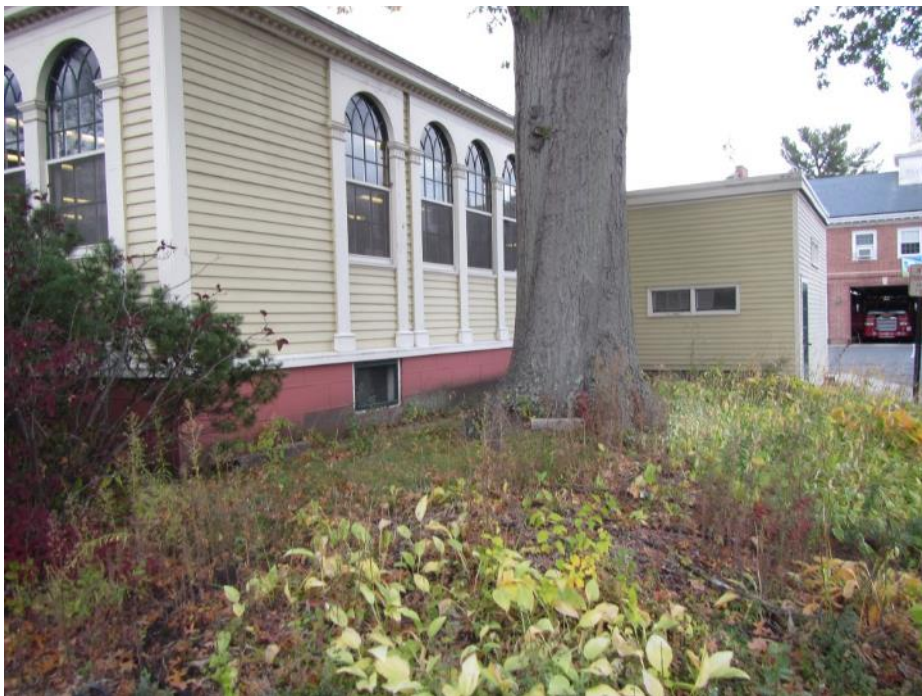
**Picture 6**

- Also of note is resistance of the oak tree to uprooting during high wind events. In general a tree root system will spread out in all directions from its trunk. As noted previously, an oak tree root can extend in a 196 foot diameter from its trunk. Any structure disrupting the root structure would then to make the tree unstable if subjected to high winds from a certain direction. The east side of the tree has its root system disrupted by a sidewalk and the driveway of the GFD (Picture 6). A strong westerly wind would make the oak tree prone to falling eastward to block the GFD driveway. If the oak tree is subjected to strong southeasterly winds, which are rare but possible, it is feasible that the tree can uproot to fall on the GPL.

**The east side of the tree has its root system disrupted by a sidewalk and the driveway of the Greenfield Fire Station**

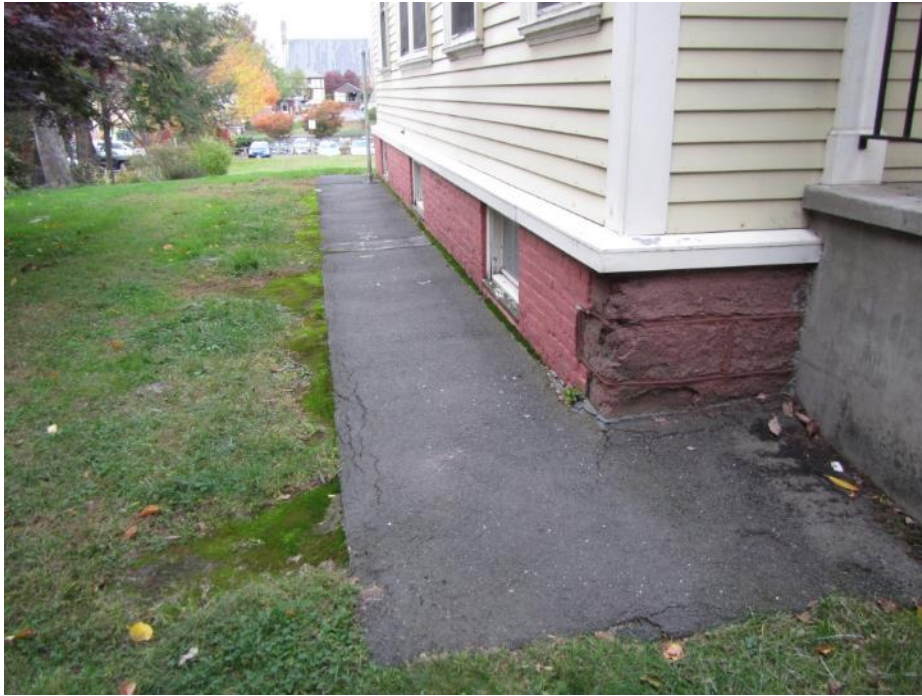
**Picture 7**

**Tarmac apron at base of the westernmost wall of the GPL**
